Environmental Liability Assessment Project Profile

Environmental Liability Assessment

International Oil and Gas Company

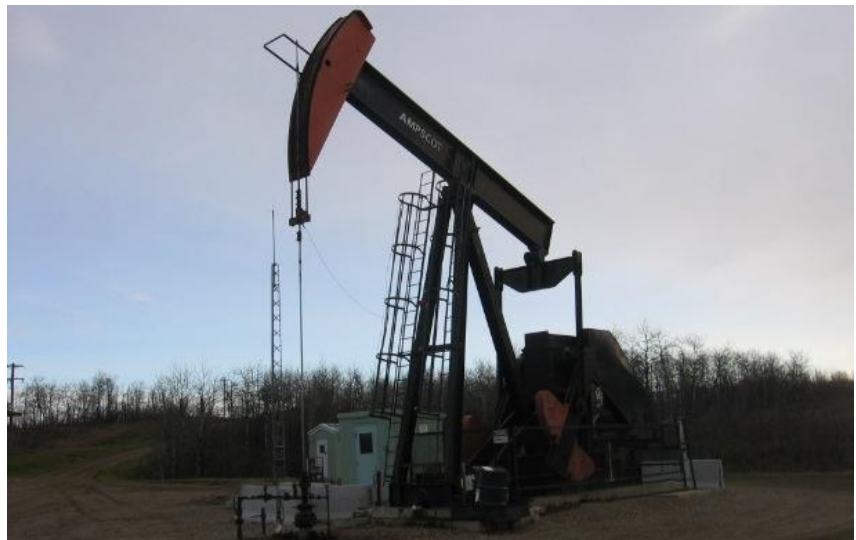
Considerable environmental liability was noted at three of the sites. Of the seven sites the greatest potential environmental liability identified was an off-site spill of a reported 60 m³ of produced water. The records review did not identify documentation that this spill was properly assessed or remediated to the applicable regulatory standards.

For more information on this project contact Darrell Haight, P.Ag., President at 780.458.7787. The photograph below shows an off-site remediation system noted at the produced water spill area.
